# Water blasting of stainless steel

By N.W. Buijs, Innomet b.v. May 2009

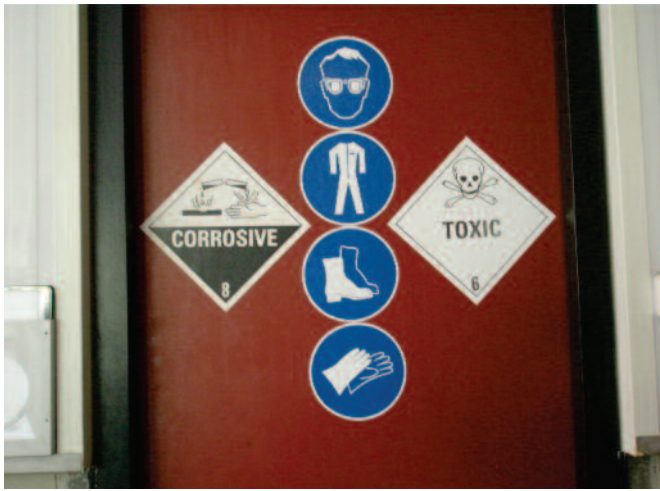
Fig. 3. Warning signs on the door of a pickling shop.

Warning signs must be placed on the door, for example, as shown in Fig. 3.

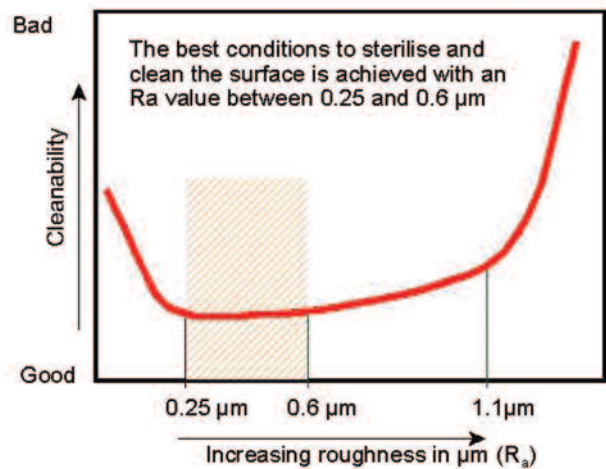
Fig. 6. Stainless steel can best be cleaned if it has a roughness between  $0.25$  and  $0.6 \mu\text{m}$  (source Leser).

large. This is shown in the diagram in Fig. 6, in which the degree of cleaning is shown as a function of the roughness. In other words, the rule 'the smoother the surface the easier it is to clean' is not always true in practice. Fig. 7 illustrates what happens in reality.

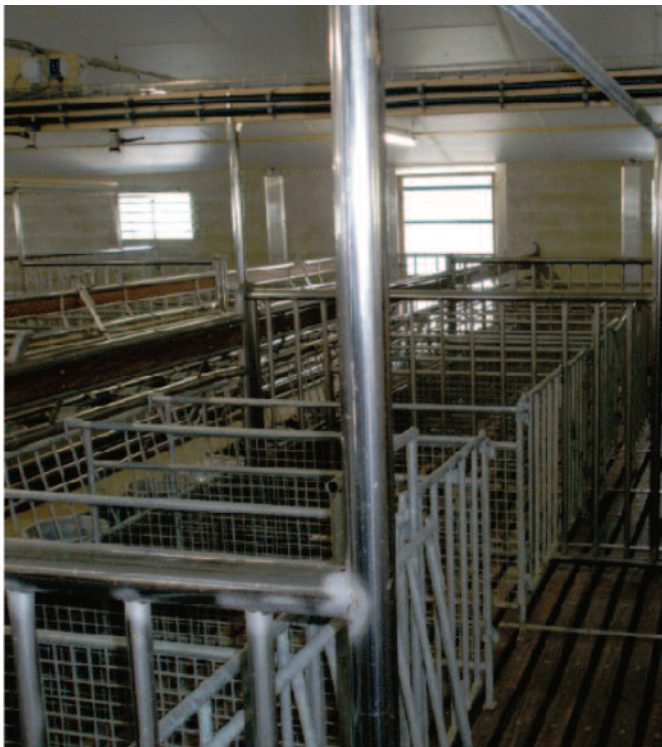
Fig. 8. The annealing colours on the welded joints have been removed with dry ice which includes an abrasive additive. This results in milky-white patches that are, however, resistant to corrosion.

A less well-known method for the removal of unwanted or burned areas from stainless steel is dry ice combined with an abrasive additive. Frozen carbon crystals with a temperature of  $-79^{\circ}\text{C}$  are blasted together with a few percent of 'ground sand' onto a stainless steel surface as a result of which the carbon dioxide transforms from a solid form into a vapour in a very short space of time. This produces sublimation as well as thermo shock on the surface. The special ground sand ensures that, one way or another, the annealing colours totally disappear. This method is efficient in itself but does have the disadvantage of being a rather noisy process. Furthermore, it requires dry ice which is relatively expensive to obtain. The advantage is that no damp residue is left behind but dust. Another disadvantage is that the surface is left a milky white colour which does little to benefit its appearance. An example of this can be seen in Fig. 8.

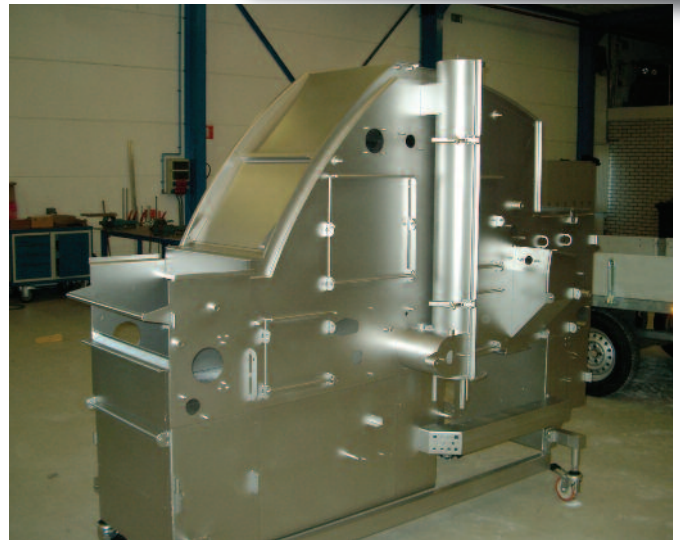
Figure 9: A breadcrumbs device treated with water blasting.

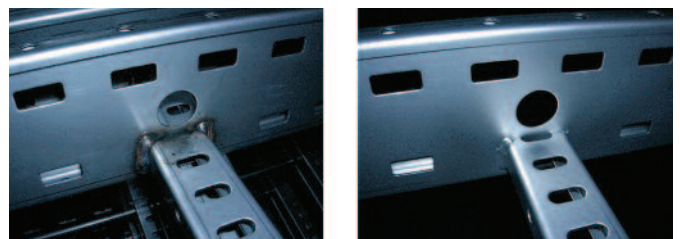
Fig. 10. Stainless steel cable channel treated with water blasting.

steel cable channel that has been treated with water blasting as an experiment instead of pickling. The company concerned has been very pleased with the results achieved up until now. In addition, this technology has produced an exceptionally smooth surface, which considerably reduces the chance of corrosion through aerosols.

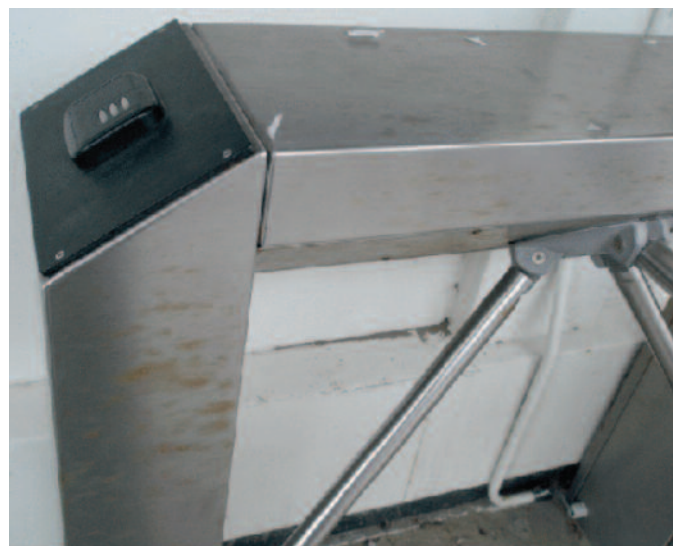
Fig. 11. Turnstile manufactured from stainless steel 316 that has been attacked by aerosols.

Aerosols are droplets of sea or brackish water, which, due to an unfavourable surface/volume ratio, evaporate relatively quickly when airborne, which increases their concentration of salt and chlorides. In other words, they have a very aggressive impact on stainless steel and even AIS 316 has great difficulty in resisting this corrosive load. These aerosols also pose a significant threat in particular for outside furniture made from stainless steel. Ground surfaces are especially susceptible to this. Fig. 11 shows a turnstile in a coastal area that has been attacked by these aerosols.
